### DIVISION OF WATER RIGHTS - DAM SAFETY SECTION

### DAM INSPECTION REPORT – 2012

Dam Name & Number	Northern Utah County – Tibble Fork, UT00299		
Date	July 12, 2012	Dam Type	Zoned Earthfill
Storage Level	6378.5ft MSL	Hazard Rating	High
Outlet Flow	0 c.f.s.	Purpose of Inspection	Annual Inspection
Spillway Flow	75 c.f.s.	Weather	Sunny & Clear, 68°F

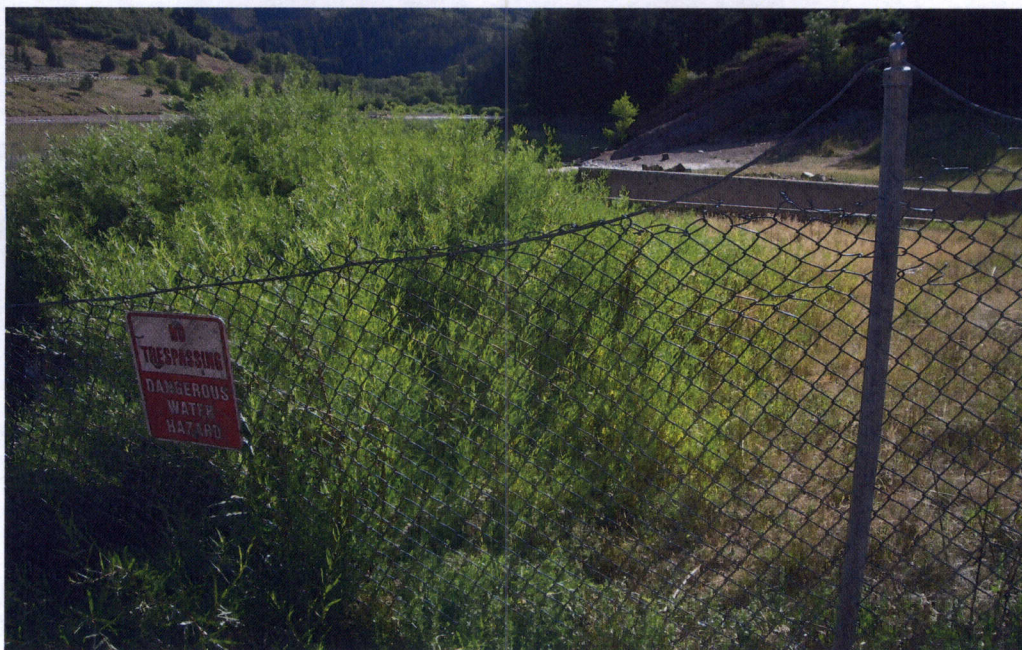
Photo 1: Willows on the upstream slope left of spillway intake need to be removed.

Checklist Item	Necessary Action, Maintenance and/or Repair:
2., 3.	Remove willows from the upstream slope to the right of the spillway intake. Remove sagebrush from the downstream slope. Exterminate burrowing rodents.

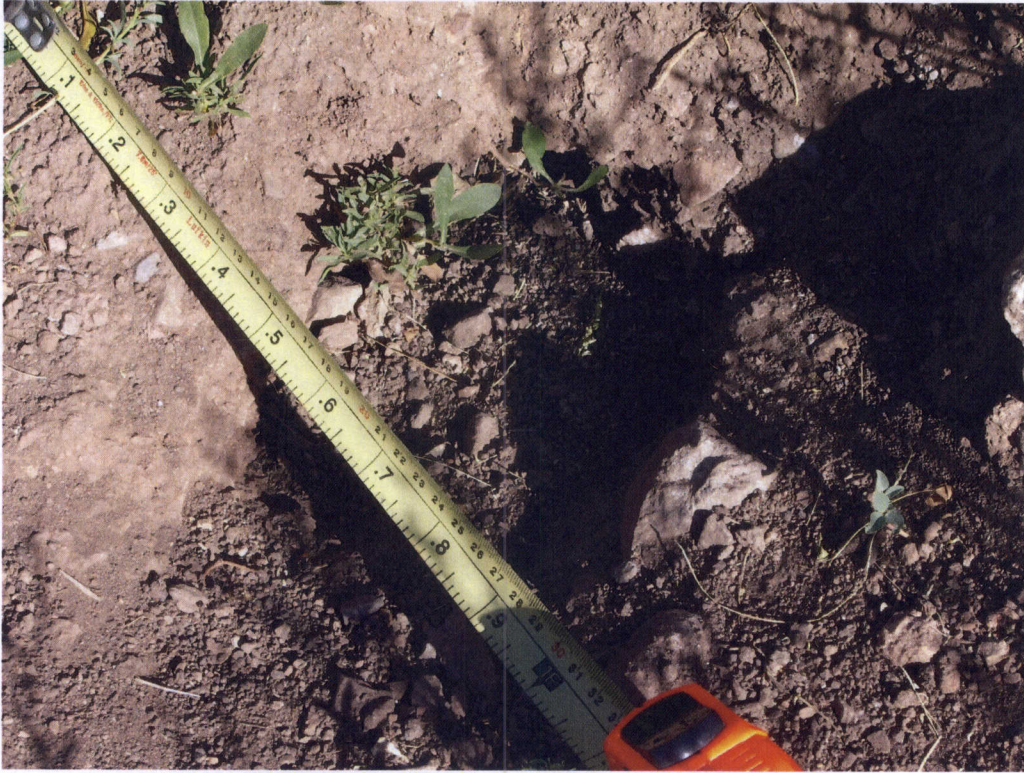
Photo 2: Example of rodent hole on downstream slope.

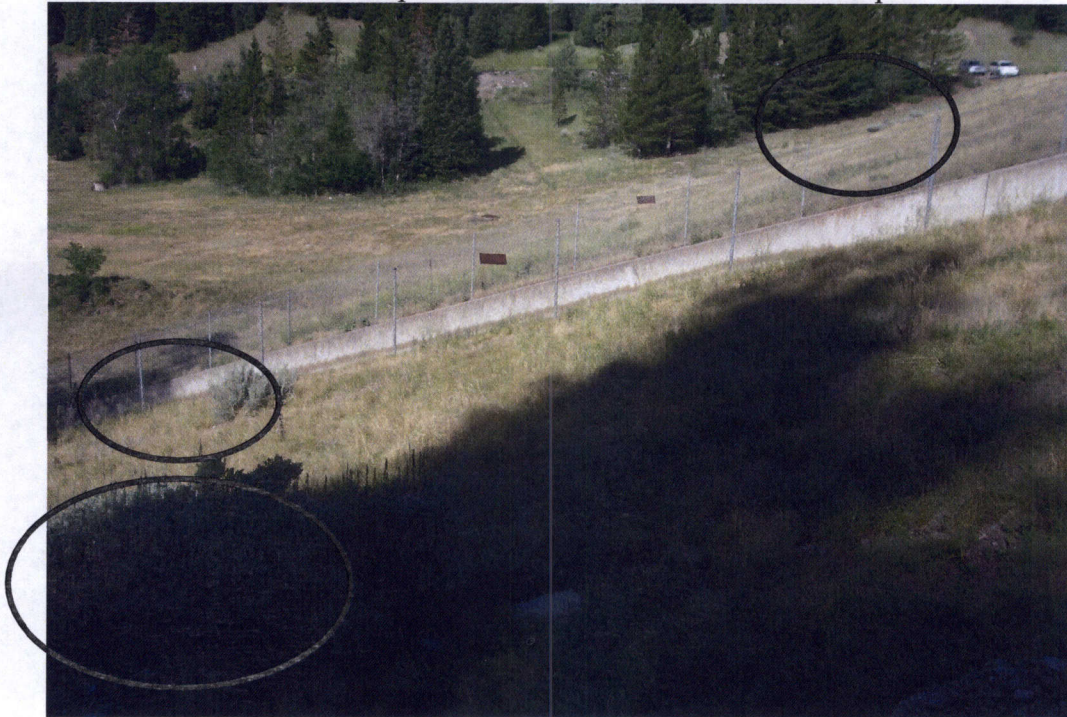
Photo 3: Remove woody vegetation from downstream slope
